## **An Investigation of Concrete Deterioration at South Florida Water Management District Structure S65E**

February 2014

Final report

Prepared for US Army Engineer District, Jacksonville  
701 San Marco Blvd  
Jacksonville, FL 32207

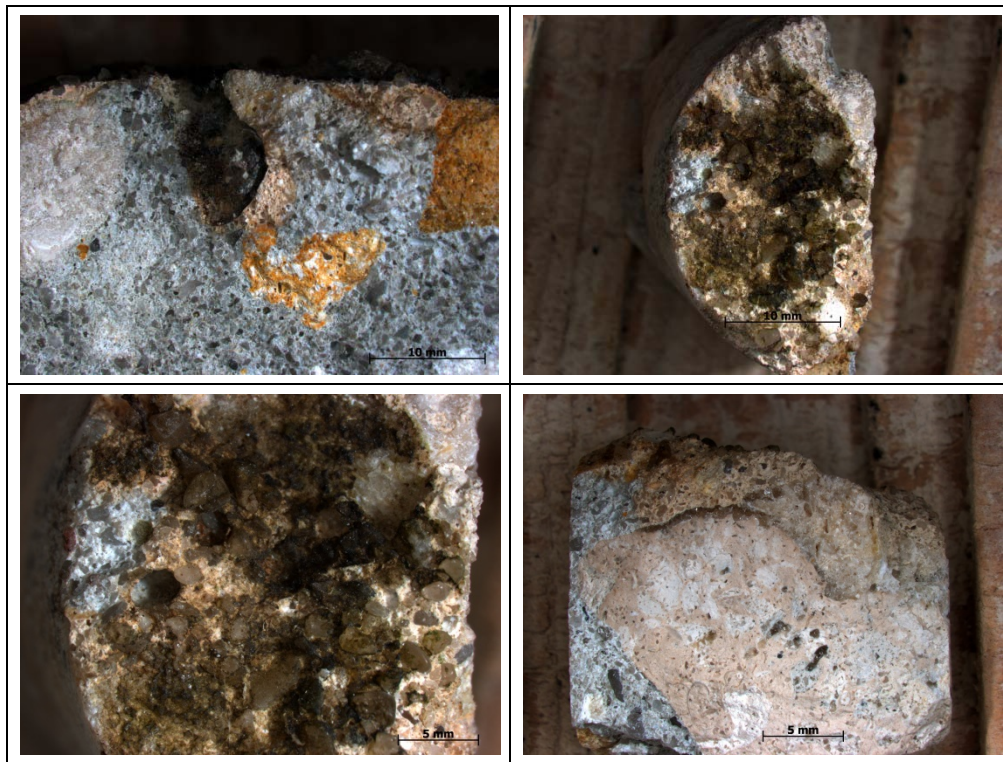
Figure A6. Supplemental photomicrographs of fractured sample of concrete, including deteriorated surface.

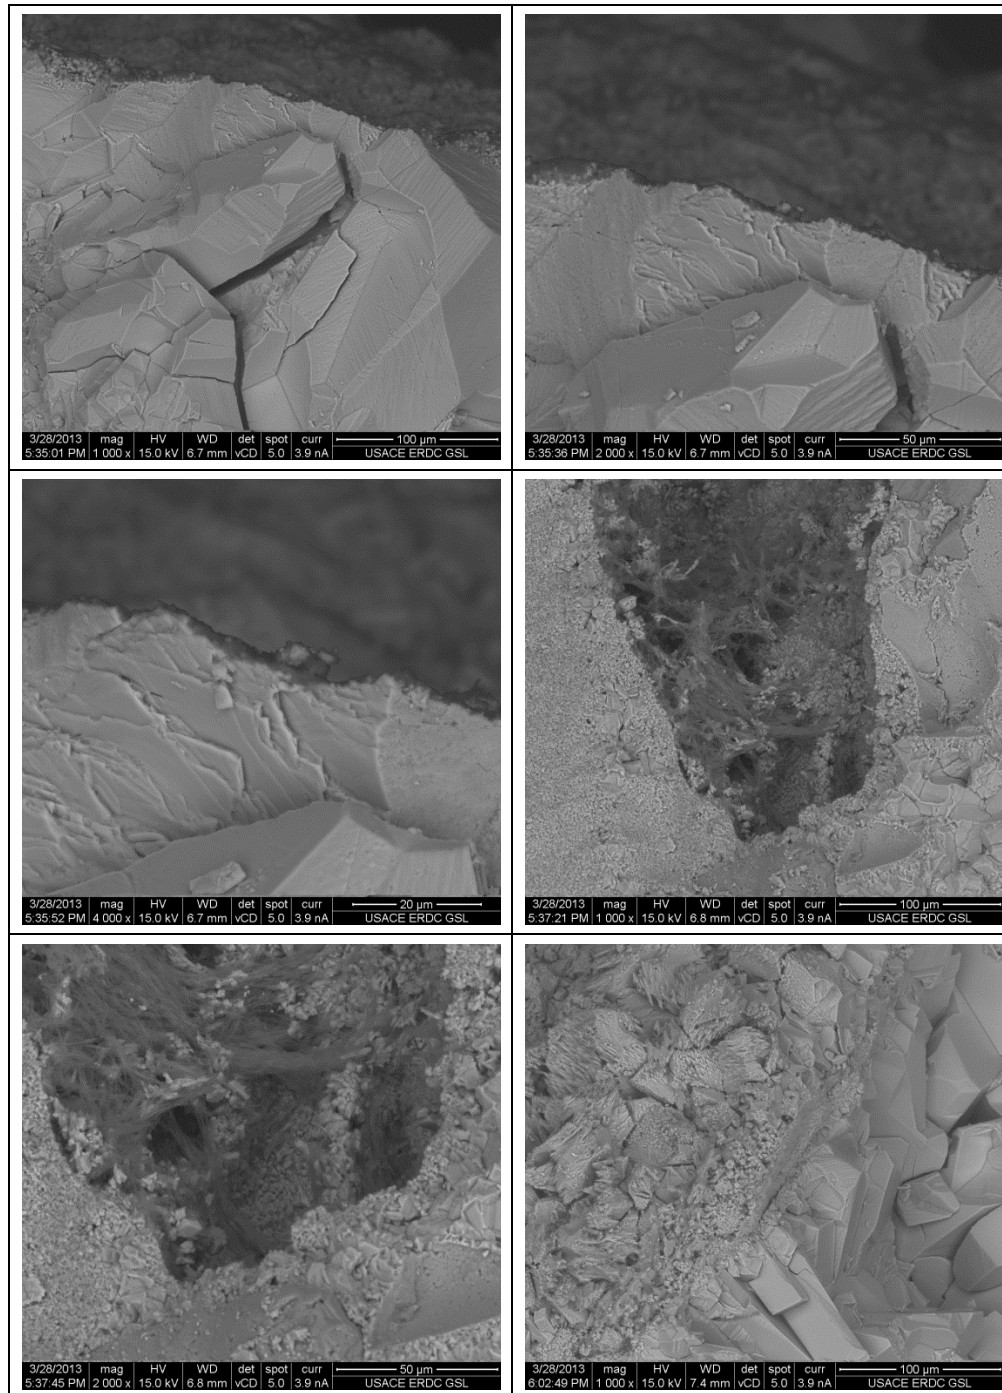
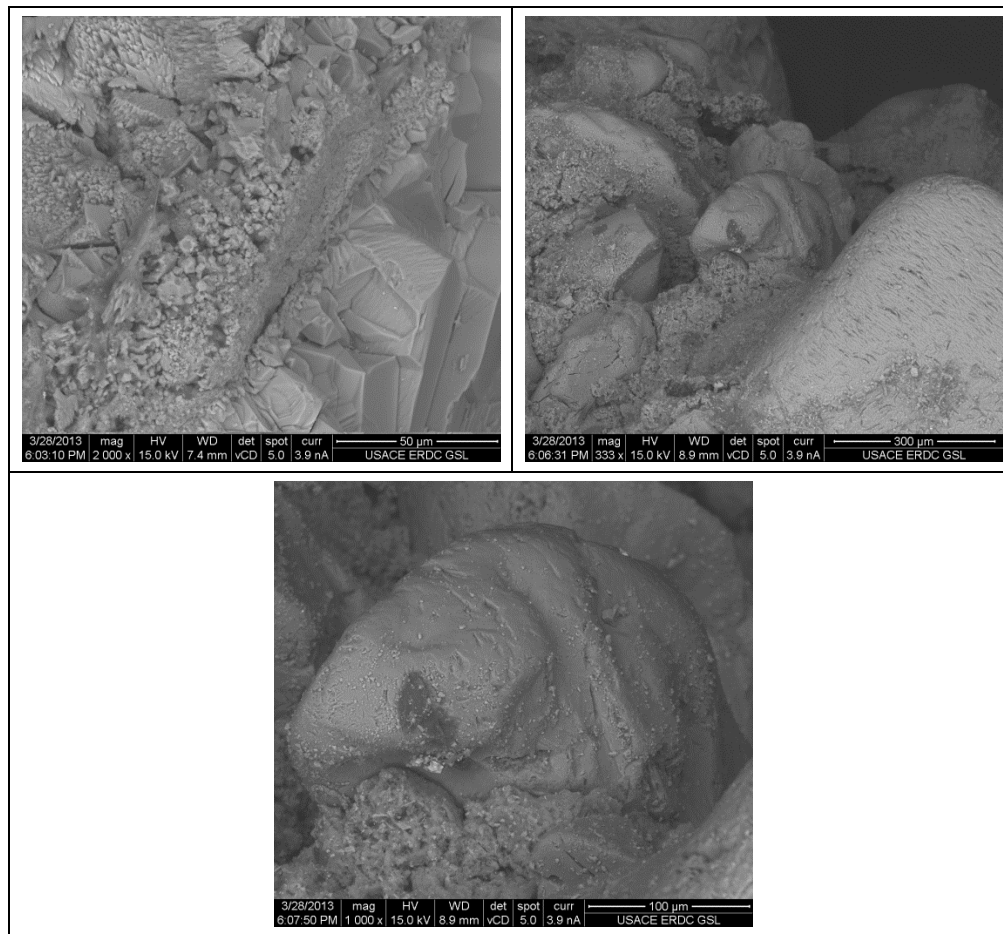
Figure B2. Supplemental SEM micrographs of fractured surface of deteriorated concrete.

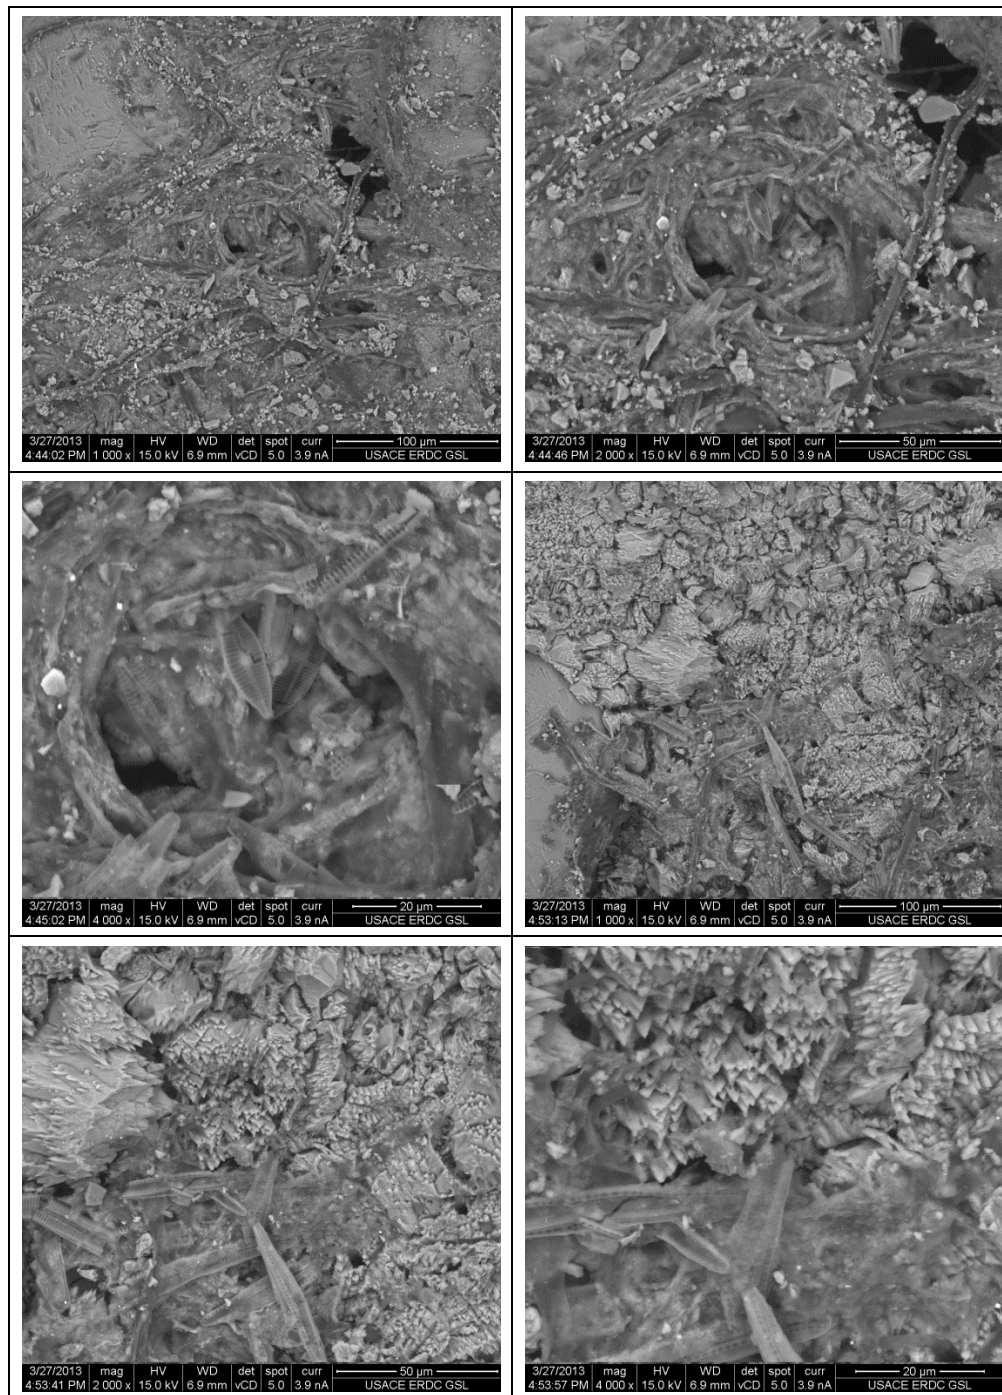
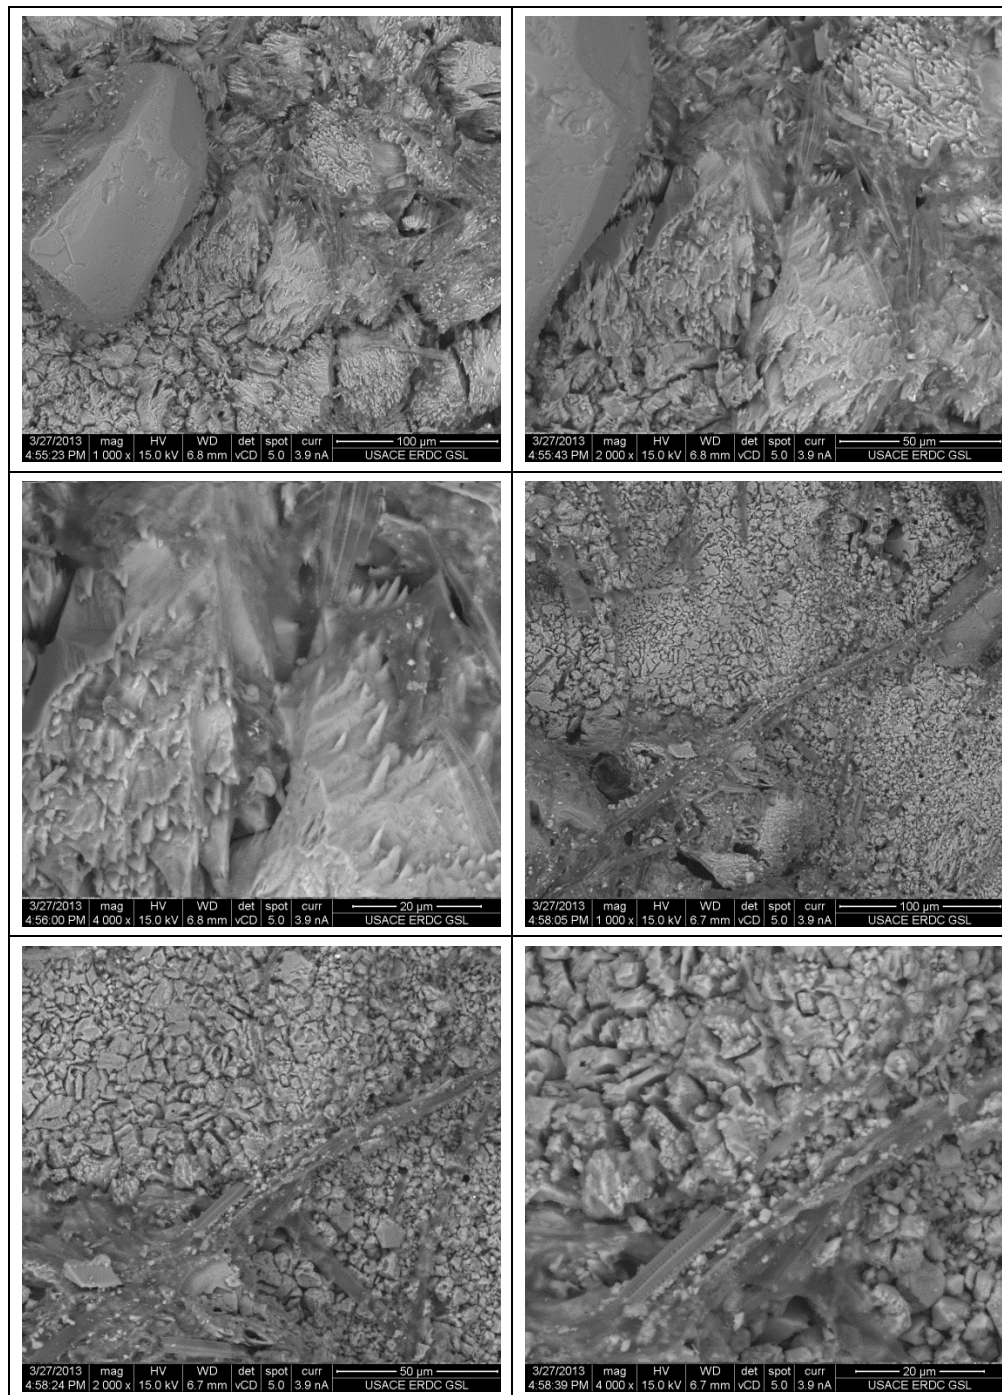
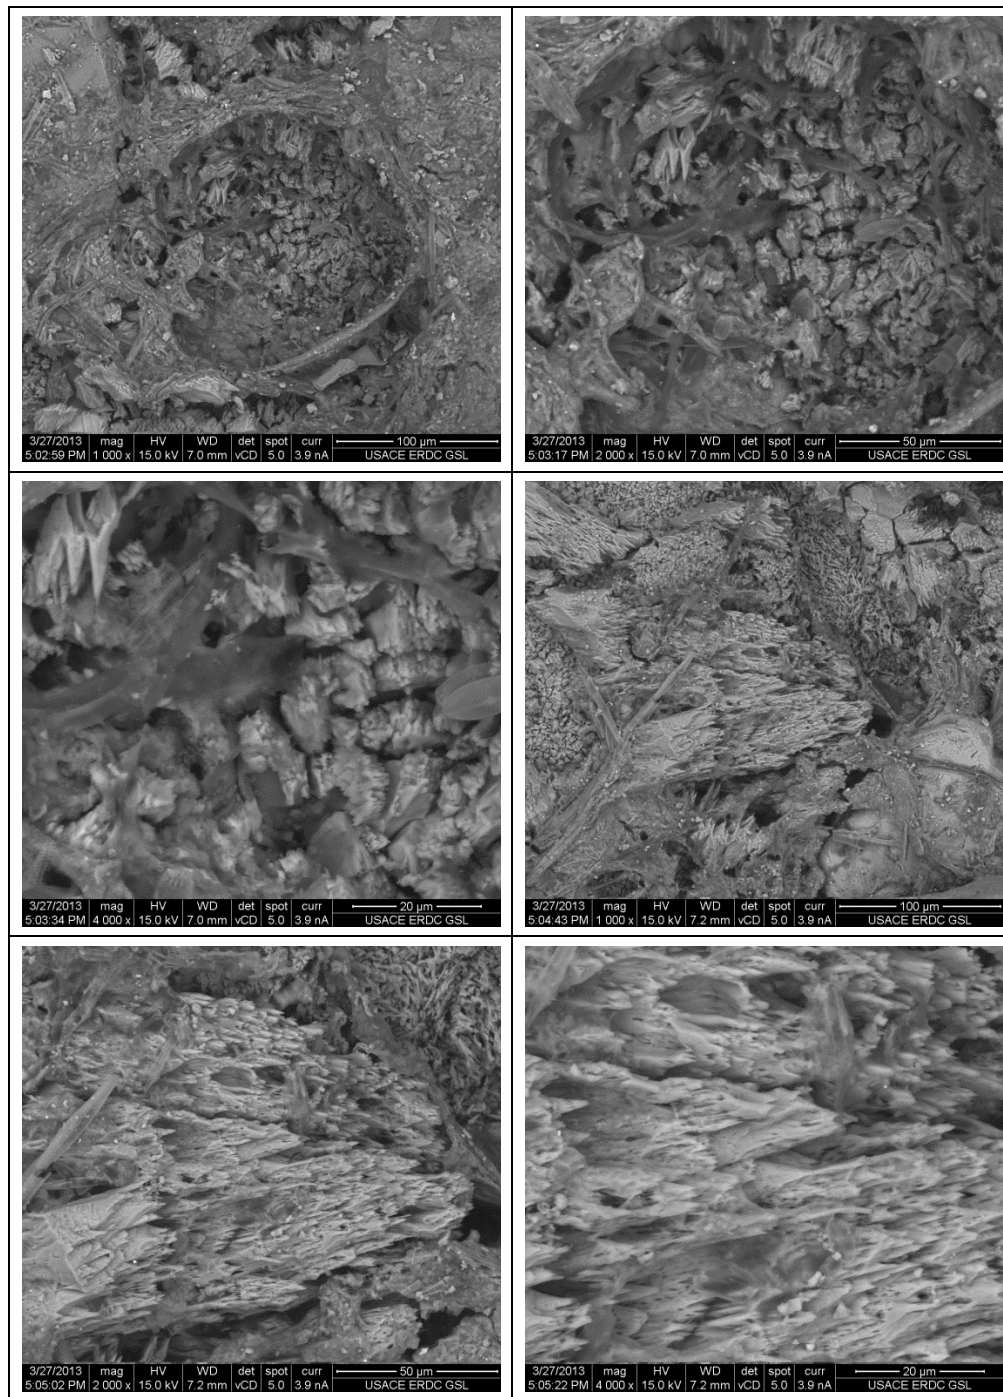
Figure B3. Supplemental SEM micrographs of exposed deteriorated concrete surface.
